DRINKING WATER STATE REVOLVING FUND
ENVIRONMENTAL INFORMATION DOCUMENT

San Antonio Water System (SAWS)
Dietrich Elevated Storage Tank (EST) Project
TWDB Project No. 62889

Freese and Nichols, Inc.
9601 McAllister Freeway, Suite 1008
San Antonio, Texas 78216

July 2020

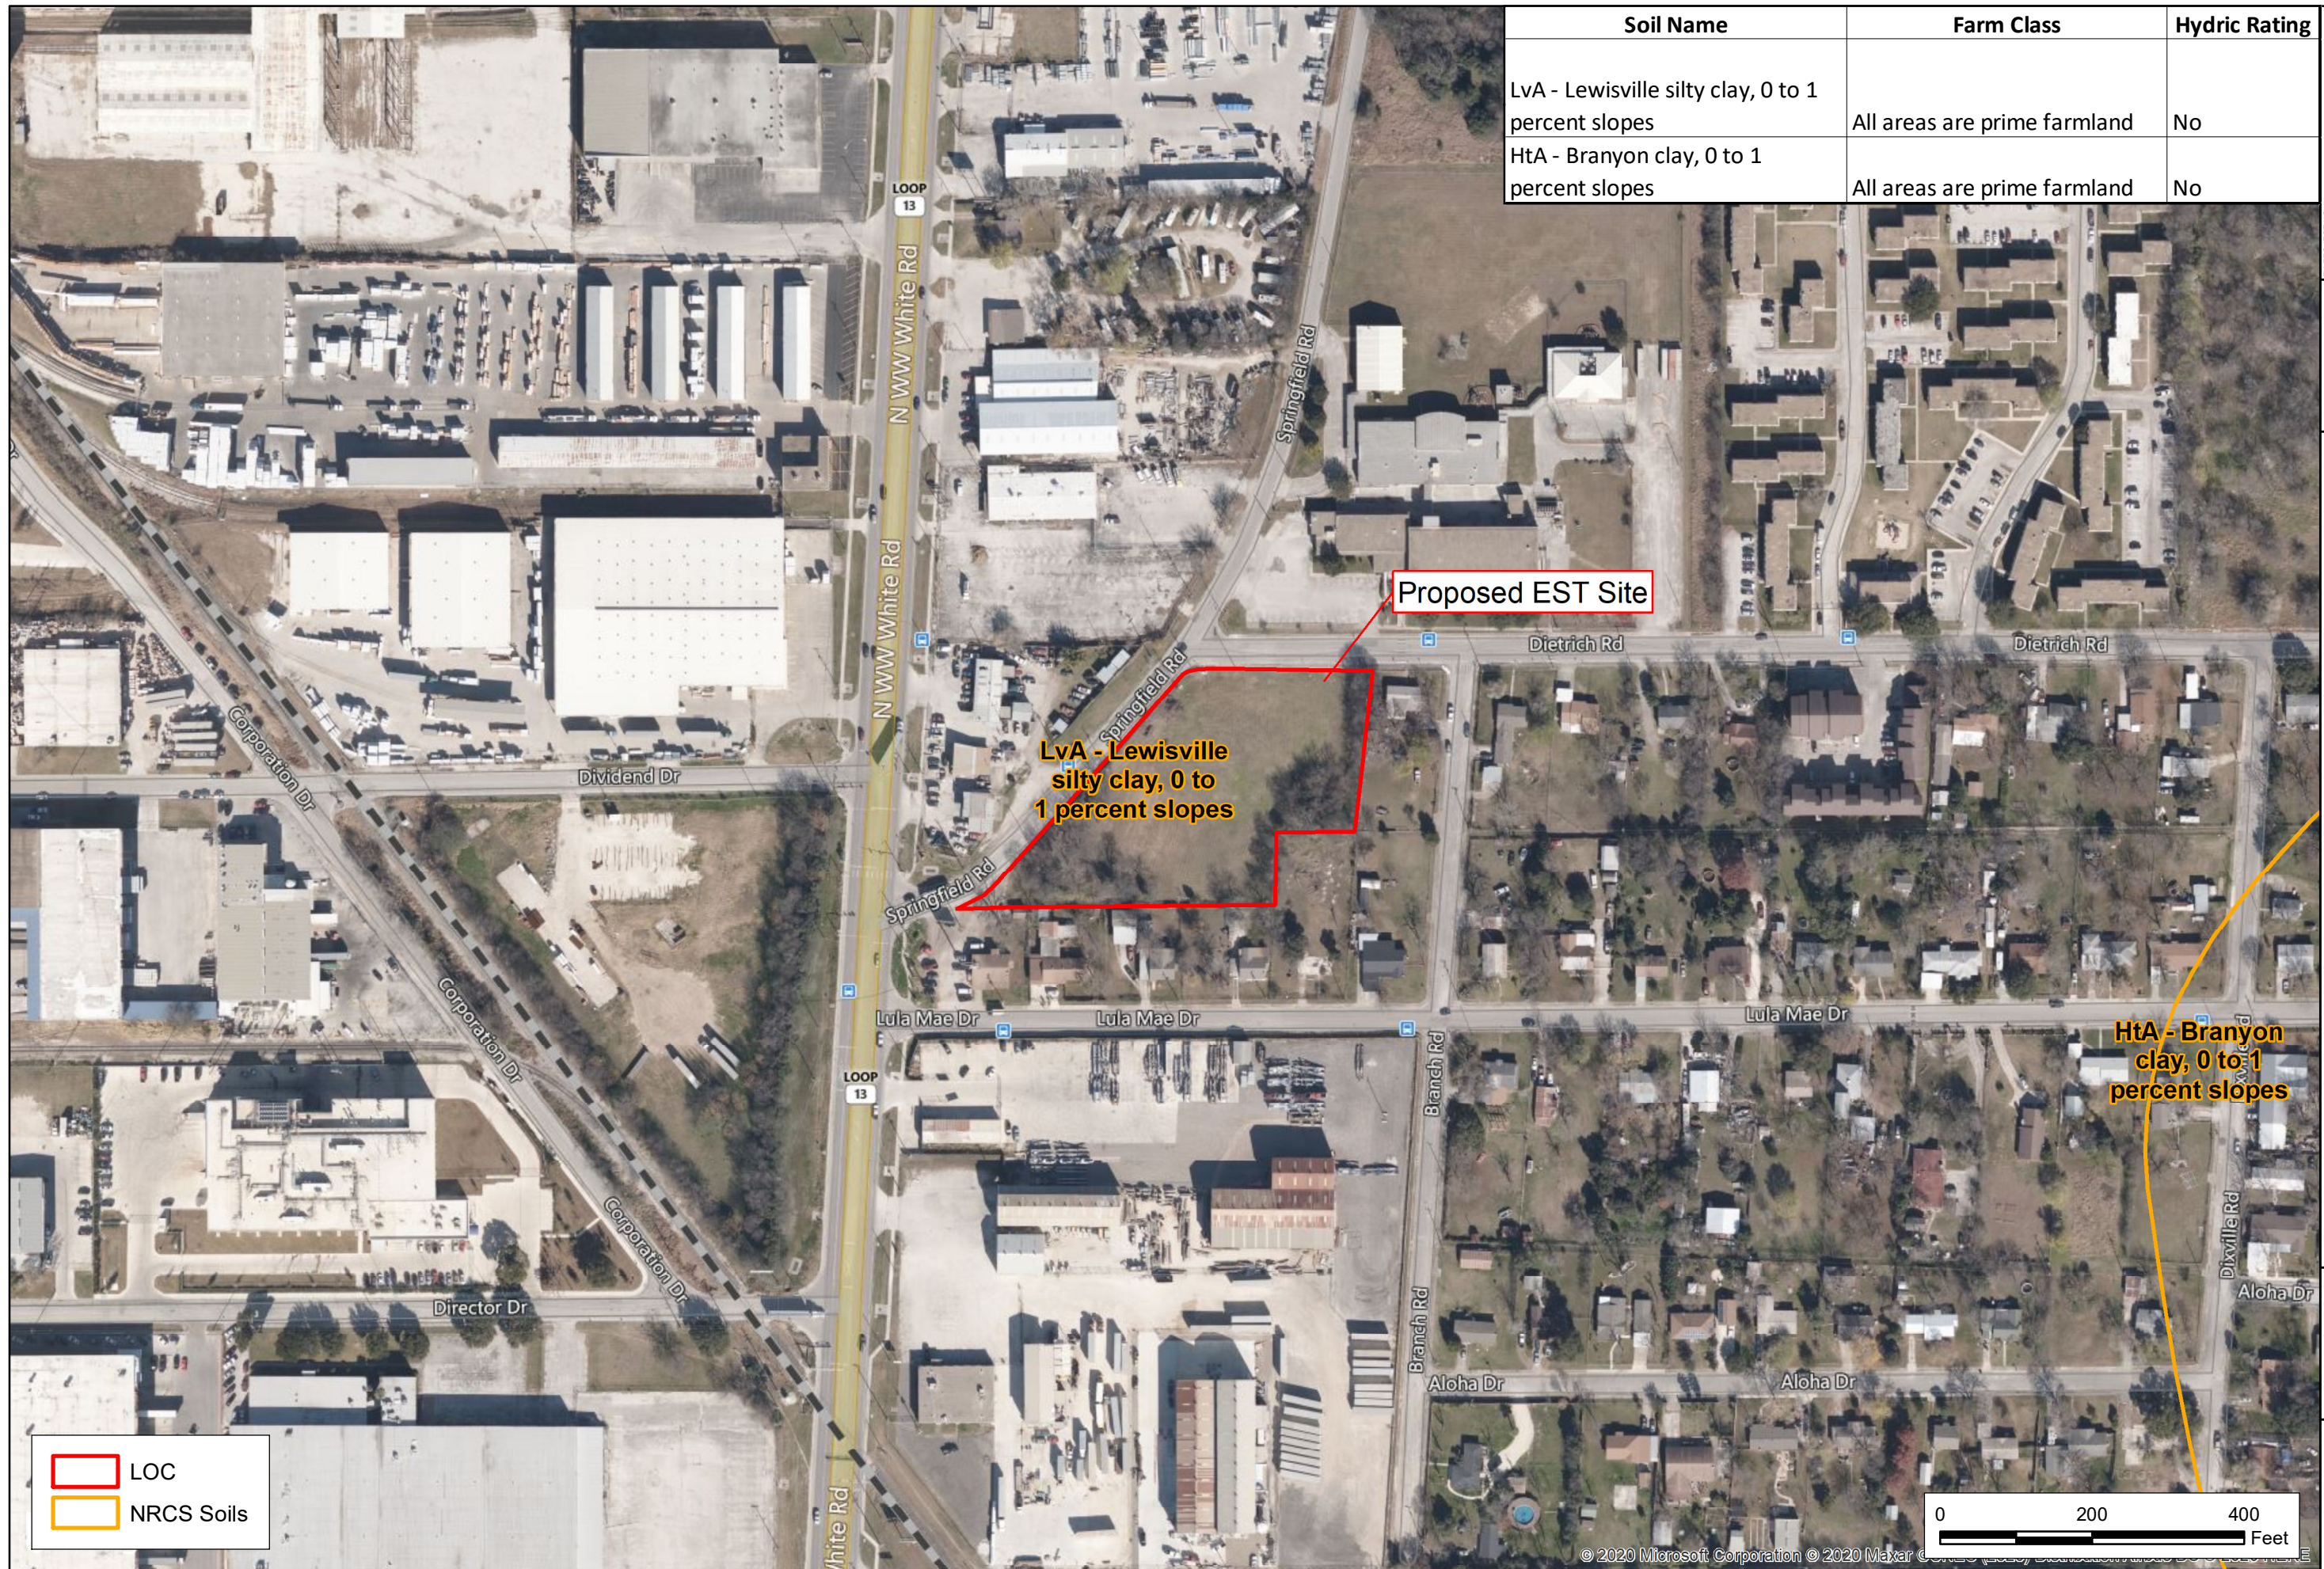
Soil Name	Farm Class	Hydric Rating
LvA - Lewisville silty clay, 0 to 1 percent slopes	All areas are prime farmland	No
HtA - Branyon clay, 0 to 1 percent slopes	All areas are prime farmland	No

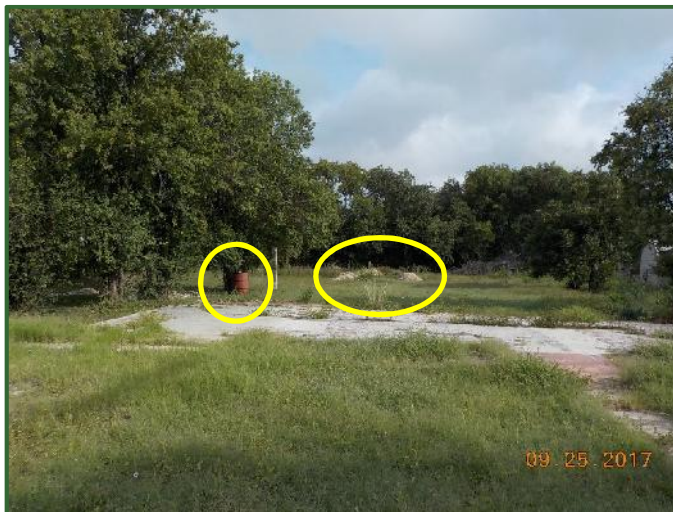
) An adjacent property to the south, located at 139 Lula Mae Drive, had an unmarked 55 gallon drum and mounds of what is likely construction debris. The site was gated and access was not available. A photograph of the drums is shown at right. The drum and mounds are circled in yellow. Because of the unknown contents of the drum, Baer Engineering considers this location a REC.

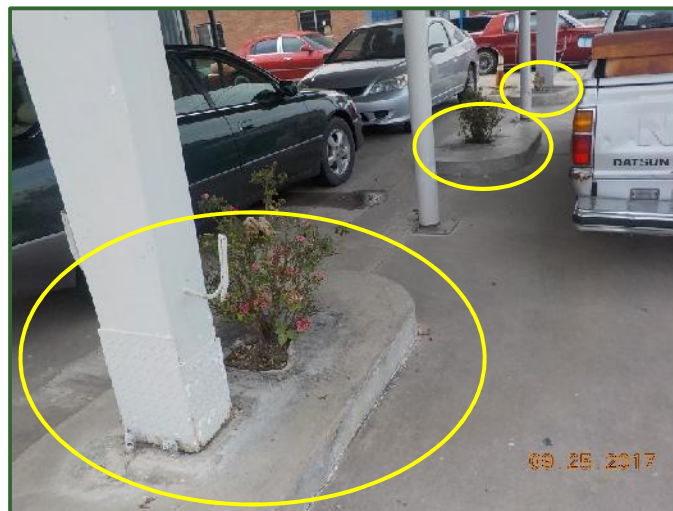
) Sam's Auto Repair, located at 518 North WW White Road, appears to be a former gasoline station. What appear to be dispenser islands remain on the site. Evidence of storage tanks on the property was not observed. A photograph is featured to the right. The fuel pumping pads are circled in yellow.

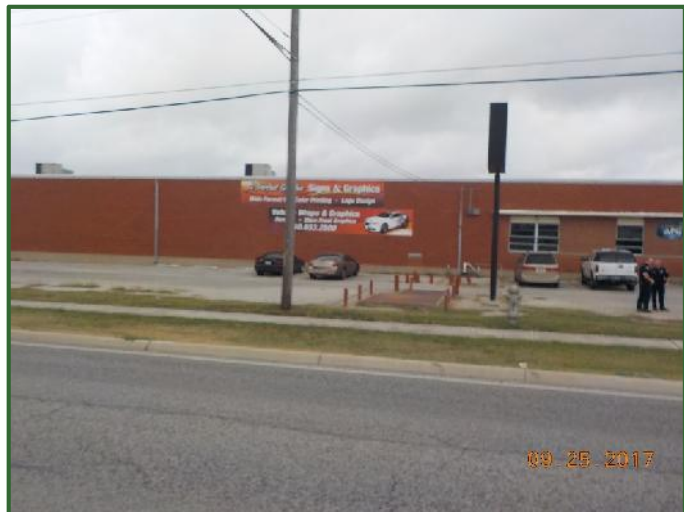
PHOTOGRAPH #5 – REC # 2 Univar USA, Inc. – San Antonio – WW White, located at 631 North WW White Road.

REC #	SITE NAME	LOCATION	TYPE	RATIONALE
1	Univar USA, Inc. – San Antonio – WW White	631 North WW White Road Distance from Site: 945 feet Topographic gradient relative the Site: Upgradient	IHW Corrective Action	Because of the presumed direction of groundwater flow, distance from the Site, and mobility of some of the contaminates, Baer Engineering considers this location to be a REC.
2	Roberts Automotive Center	515A North WW White Road Distance from Site: 150 feet Topographic gradient relative the Site: Upgradient	Historical Auto Station	TCEQ records list the USTs at this location as removed from the ground. Because of the adjacent location, Baer Engineering considers this location to be a REC.
3	Dependable Transm & Auto SVC	518 North WW White Road Distance from Site: Adjacent Topographic gradient relative the Site: Upgradient	Historical Auto Station	Additional records were not located for this property. Because of the unknown status of USTs for this property, Baer Engineering considers this property to be a REC.

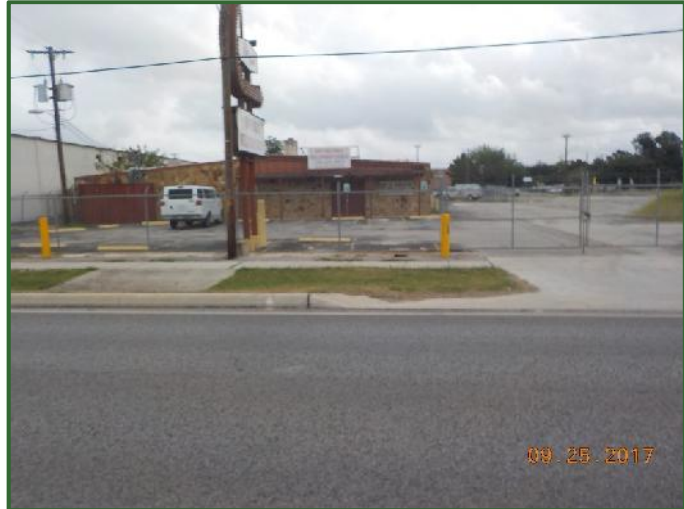
PHOTOGRAPH #7 – REC #5 New Genesis, located at 542 North WW White Road.

REC #	SITE NAME	LOCATION	TYPE	RATIONALE
4	New Genesis	542 North WW White Road Distance from Site: Adjacent Topographic gradient relative the Site: Upgradient	Historic Dry Cleaners	Additional records were not located for this property. Because of the unknown status of the dry cleaners for this property and unknown chemicals used, Baer Engineering considers this property to be a REC.
5	139 Lula Mae Drive	139 Lula Mae Drive Distance from Site: Adjacent Topographic gradient relative the Site: Downgradient	Drum with unknown contents	Because of the unknown contents of the drum and adjacent location, Baer Engineering considers this location a REC.

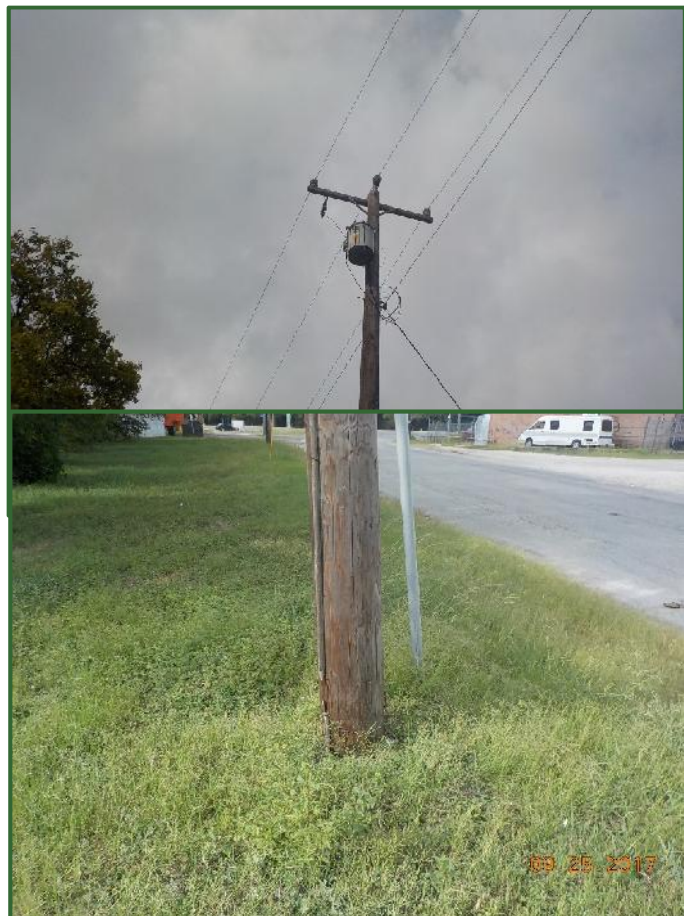
PHOTOGRAPH #8 and 9– Unmarked transformer and vegetation at the base of the pole on the Site.
